YPG REPORT 9001

ENGINEERING TEST (DESERT) OF EFFLUENT

FUEL TESTER, TOTAMITOR, 50 GPM

AND 400 GPM

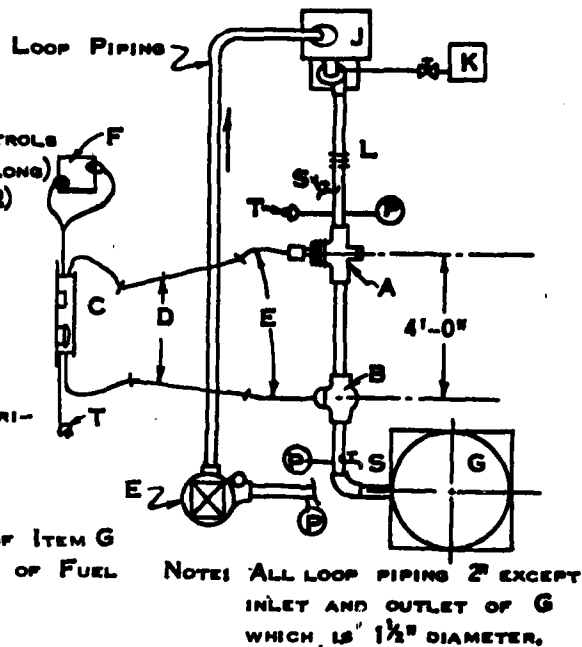
FIGURE 1. LAYOUT EFTT 50 IN CLOSED LOOP PIPING SYSTEM.

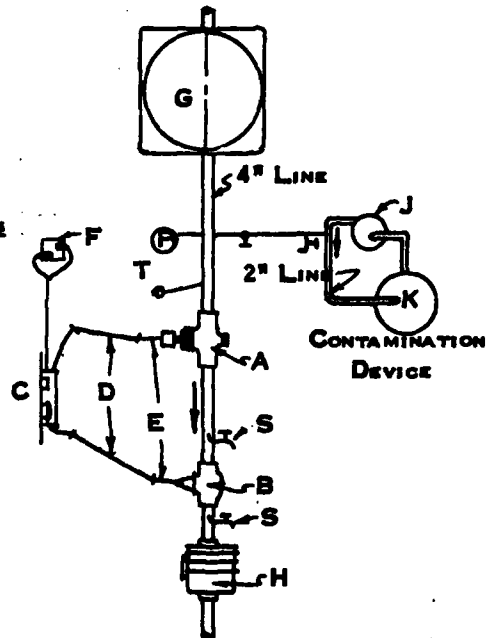
FIGURE 2. LAYOUT EFTT 400 WITH SECTIONS OF CLOSED LOOP PIPING SYSTEM.

Solids contaminate (red iron oxide  $\text{Fe}_2\text{O}_3$ ) and water contaminate were independently mixed with test fuel and hand stirred in a 55-gallon drum. This mixture was pumped with a secondary centrifugal pump into the pickup head inlet line (Fig. 2). Fuel samples were taken from the pickup head outlet.

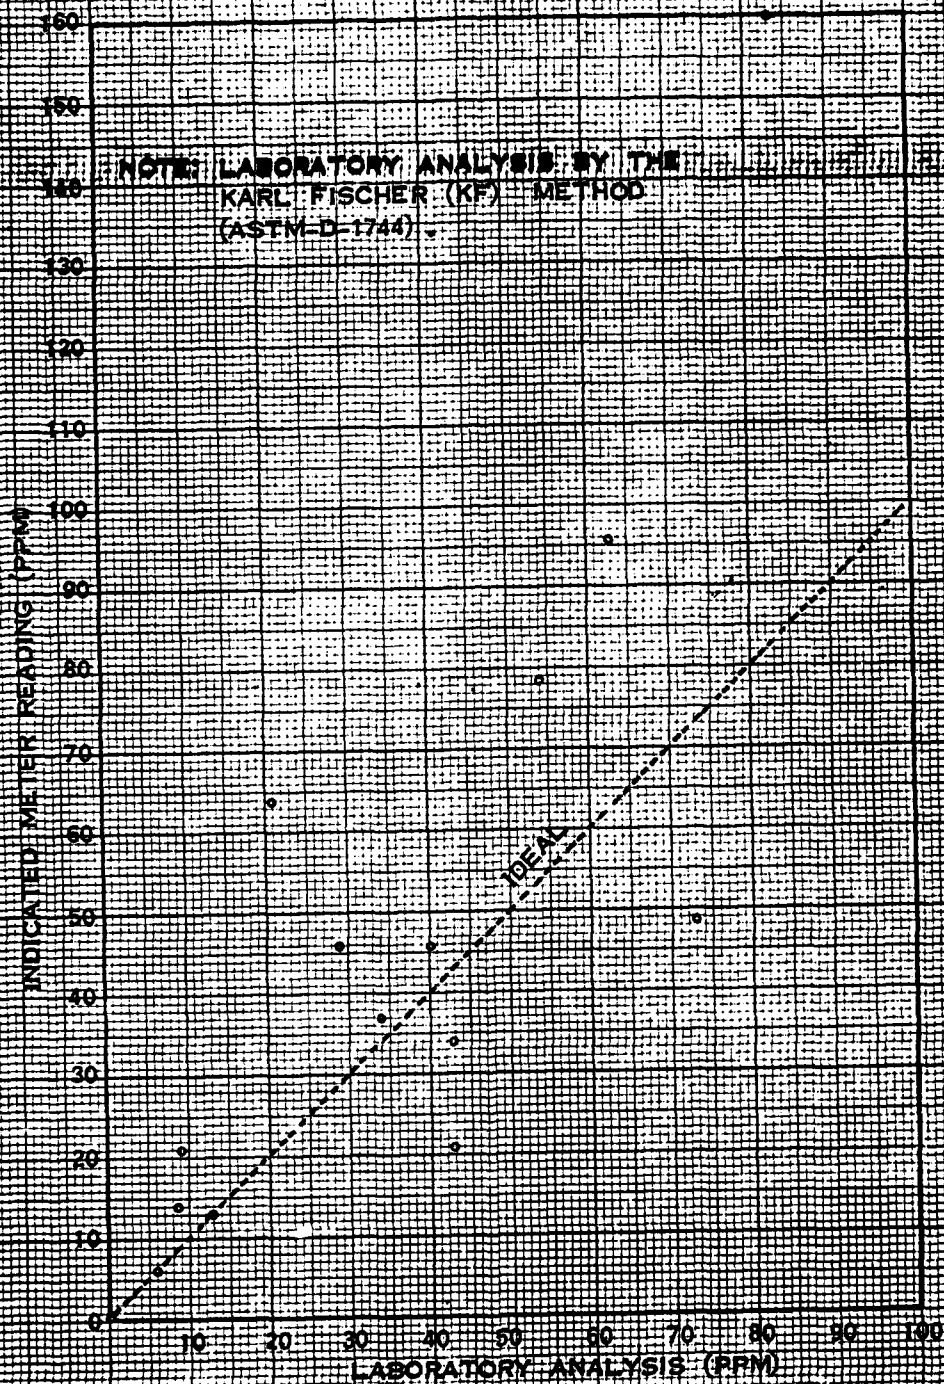
GRAPH 1. EFT 400 MOGAS CONTAMINATED WITH WATER.

(2) There was a wide variance between amplifier contaminant meter readings and actual contamination introduced for test purposes (paragraph 2.4.5, charts 1 and 3, Appendix I, reference 1b). This condition is reclassified as a deficiency because the meter indicated much higher contamination than the actual amount.

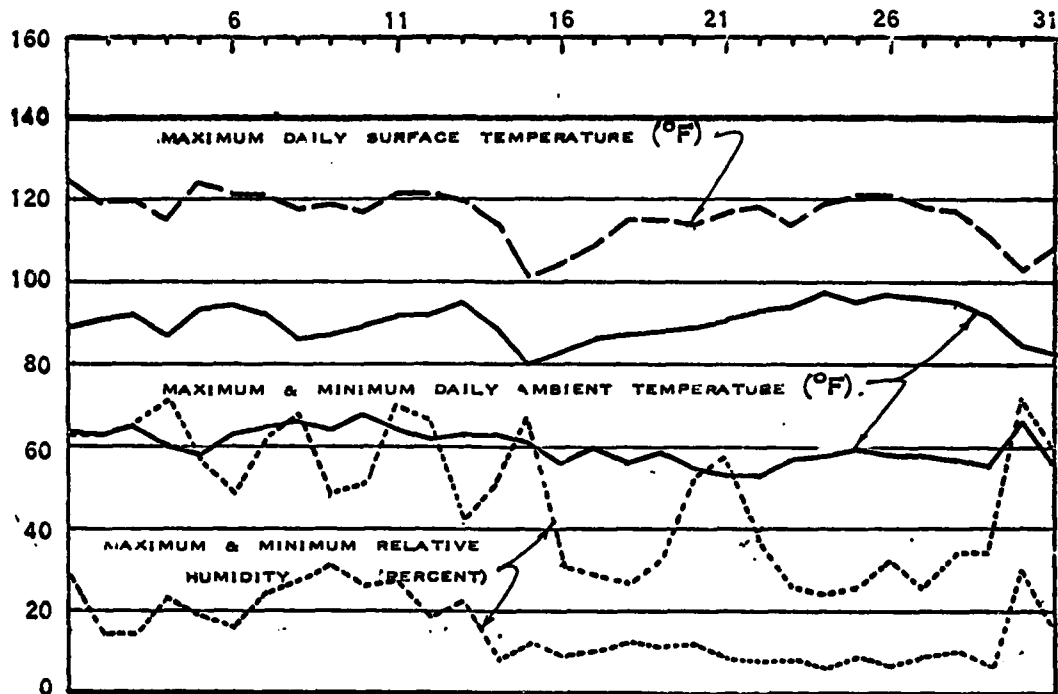
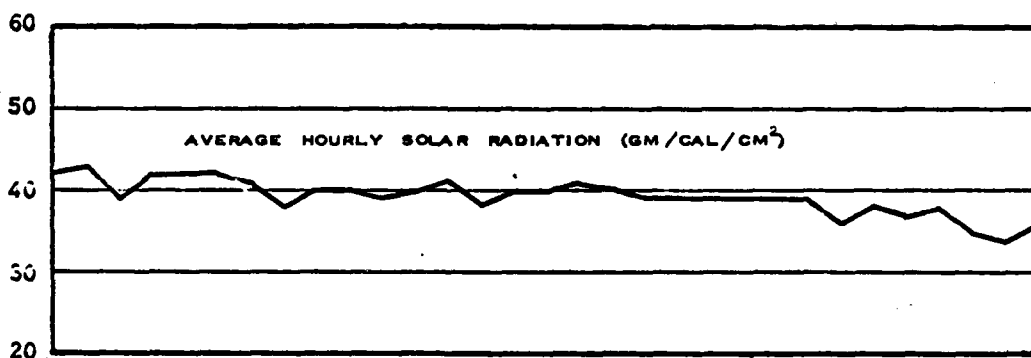
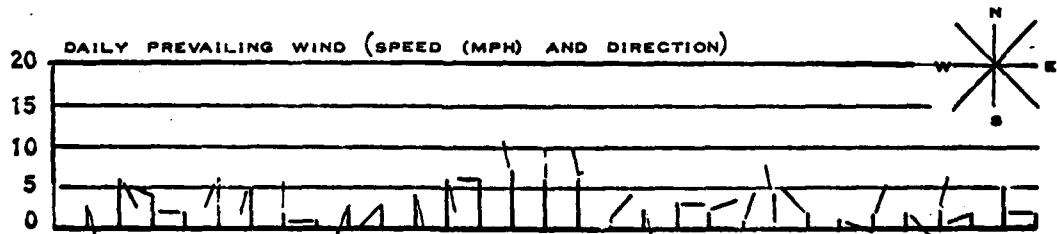
**YUMA PROVING GROUND, YUMA, ARIZONA  
METEOROLOGICAL SUMMARY FOR OCTOBER 1968**

**DAILY AVERAGE SKY CONDITION**      **C - CLEAR    P - PARTLY CLOUDY & CLOUDY**

C C C C C C C C P P C C C C C C C C C C C C C C C C C C P P C 23

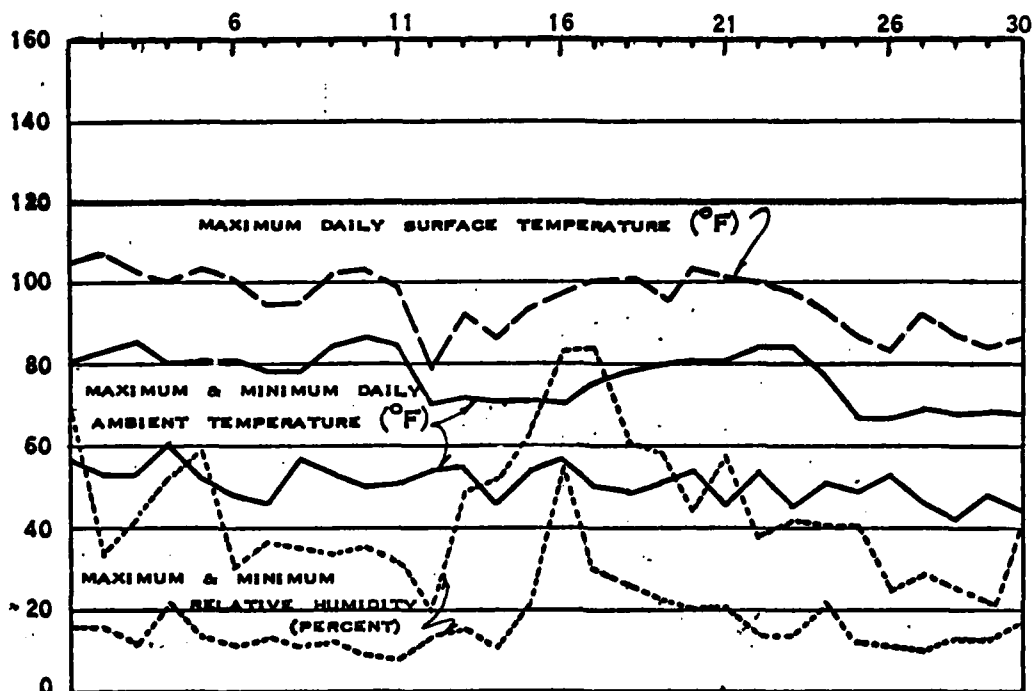
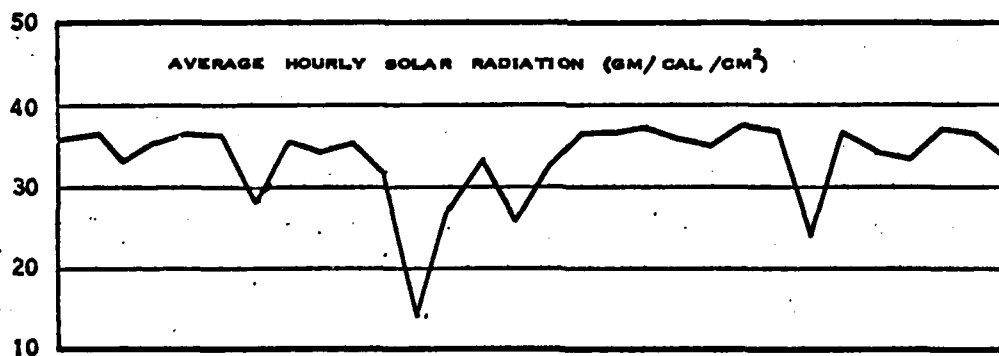
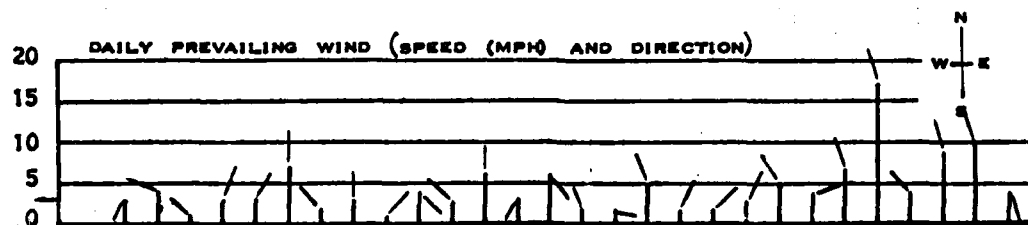
**YUMA PROVING GROUND, YUMA, ARIZONA  
METEOROLOGICAL SUMMARY FOR NOVEMBER 1968**

**DAILY AVERAGE SKY CONDITION**      C - CLEAR    P - PARTLY CLOUDY & CLOUDY

C C P P C C P C C C P P C P C C C C C C C C P C C C C C P

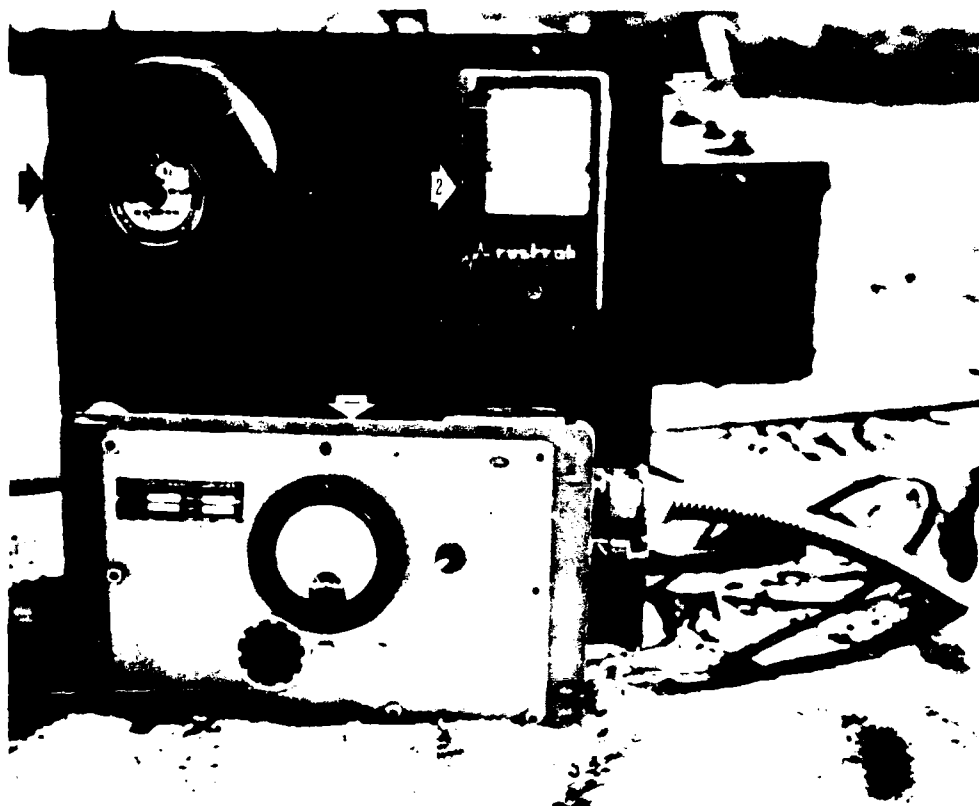
FIGURE 1. Controls and instruments installed on EFTT 50. Identical items used on EFTT 400. 1. Amplifier. 2. Recorder. 3. Alarm, 4. Battery.

When the simulator button on the pickup head was depressed and then released with the amplifier range knob set at 50 ppm and with ambient temperatures of  $105$  to  $110^\circ\text{F}$ , the control valve would close and would fail to reopen when the simulator button was released. This amplifier failure occurred twice. The amplifier was on the ground and was not shaded (App III). At an ambient temperature of  $105^\circ\text{F}$ , temperatures of the unshaded amplifier and of the fuel were  $120$  and  $116^\circ\text{F}$ , respectively. At an ambient temperature of  $110^\circ\text{F}$ , the amplifier and fuel temperatures were  $130$  and  $134^\circ\text{F}$ , respectively. With the amplifier range knob set at 100 ppm, at an indicator meter reading of 29 ppm ( $\text{Fe}_2\text{O}_3$  being injected) and at an ambient temperature of  $113^\circ\text{F}$ , the control valve closed unexpectedly. The amplifier was on the ground and was shaded at the time of this failure. Temperature inside the amplifier was  $120^\circ\text{F}$  and fuel temperature was  $143^\circ\text{F}$  (App III). The amplifier from the EFTT 400 was installed to replace the EFTT 50 amplifier and the failures above recurred.

Cooling the amplifier by artificial means (air-conditioner) restored operation; however, the same failures occurred when the amplifier heated up again.

It was noted that the recorder hinged door was not sealed and is, therefore, subject to water damage.

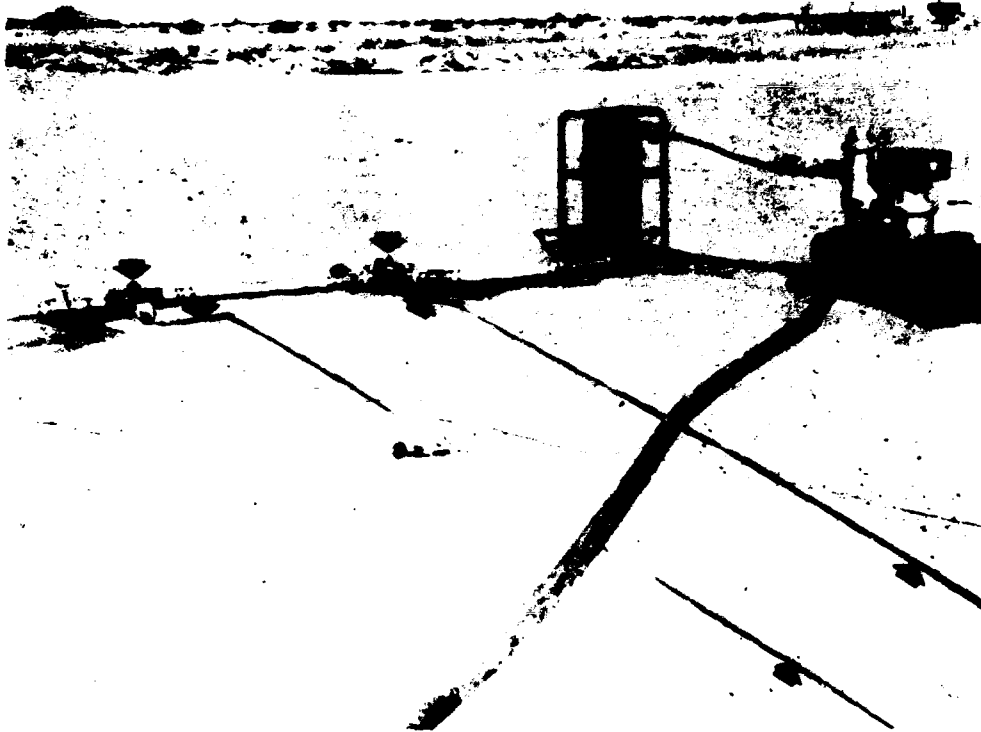
FIGURE 2. EFTT 50 components in closed loop piping system. 1. Pickup head. 2. Control valve. 3. Conduit. 4. Conduit connectors.

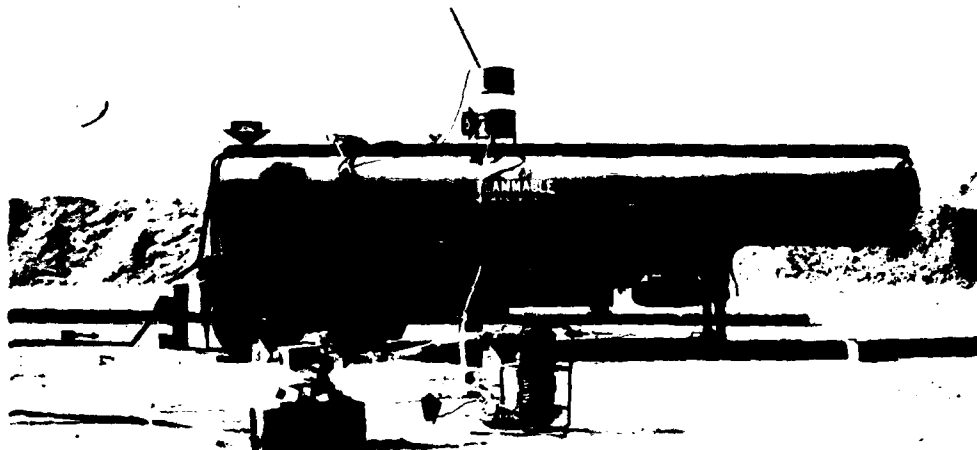
FIGURE 3. EFTT 50 test setup. 1. EFTT 50. 2. Filter/separator.  
3. Flow meter. 4. Fuel tanker. 5. Contaminant barrel.

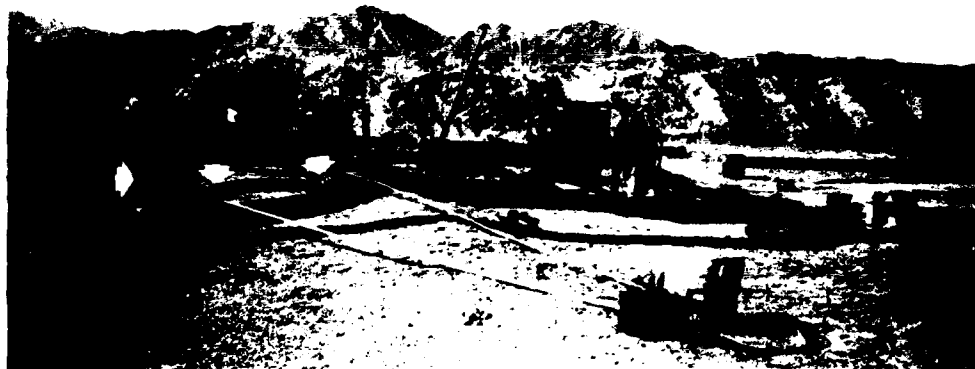
FIGURE 4. EFTT 400 test setup. 1. Detector head. 2. Control valve.  
3. Flow meter. 4. Conduit. 5. Controls and instruments.

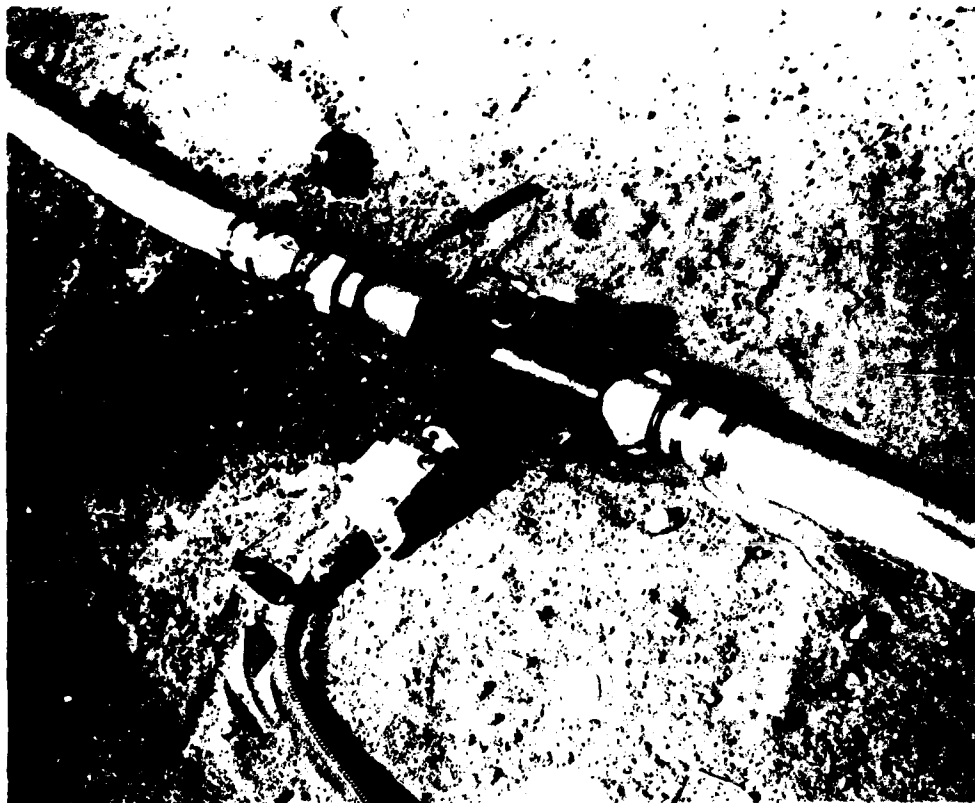
The steel conduit from the detector head photocell to the conduit box rusted on both detector heads.

FIGURE 5. EFTT 50 pickup head installed. 1. Pickup head. 2. Steel conduit tube (junction box to photocell adapter). 3. Conduit connector.

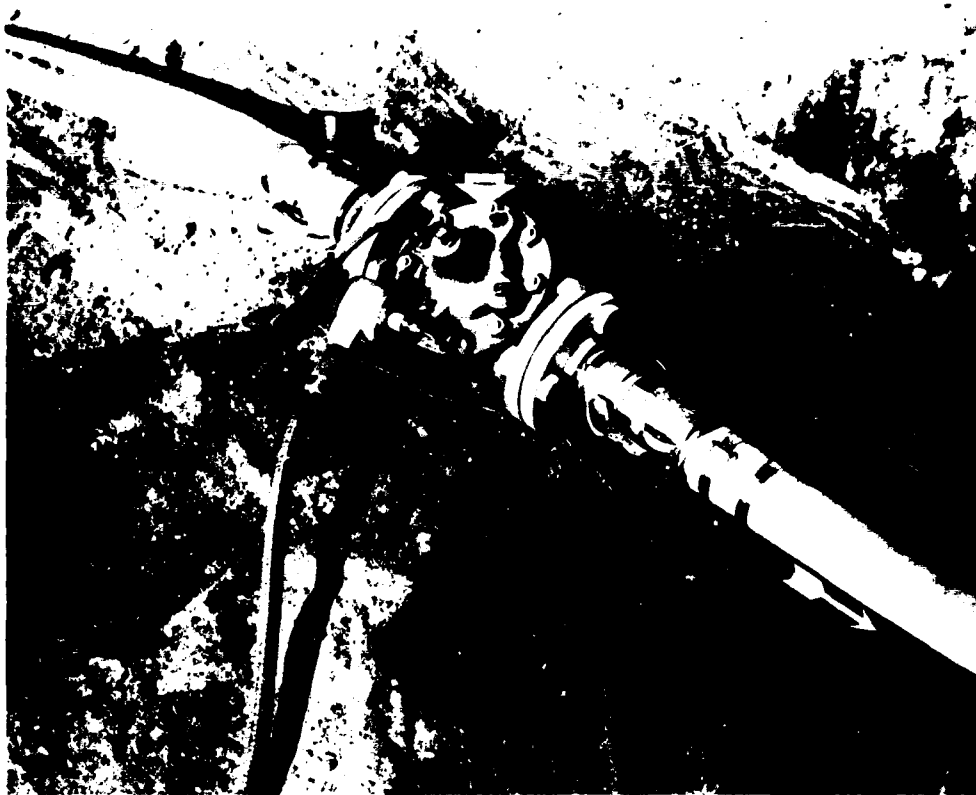
FIGURE 6. EFTT 50 control valve installed. 1. Control valve. 2. Conduit connector

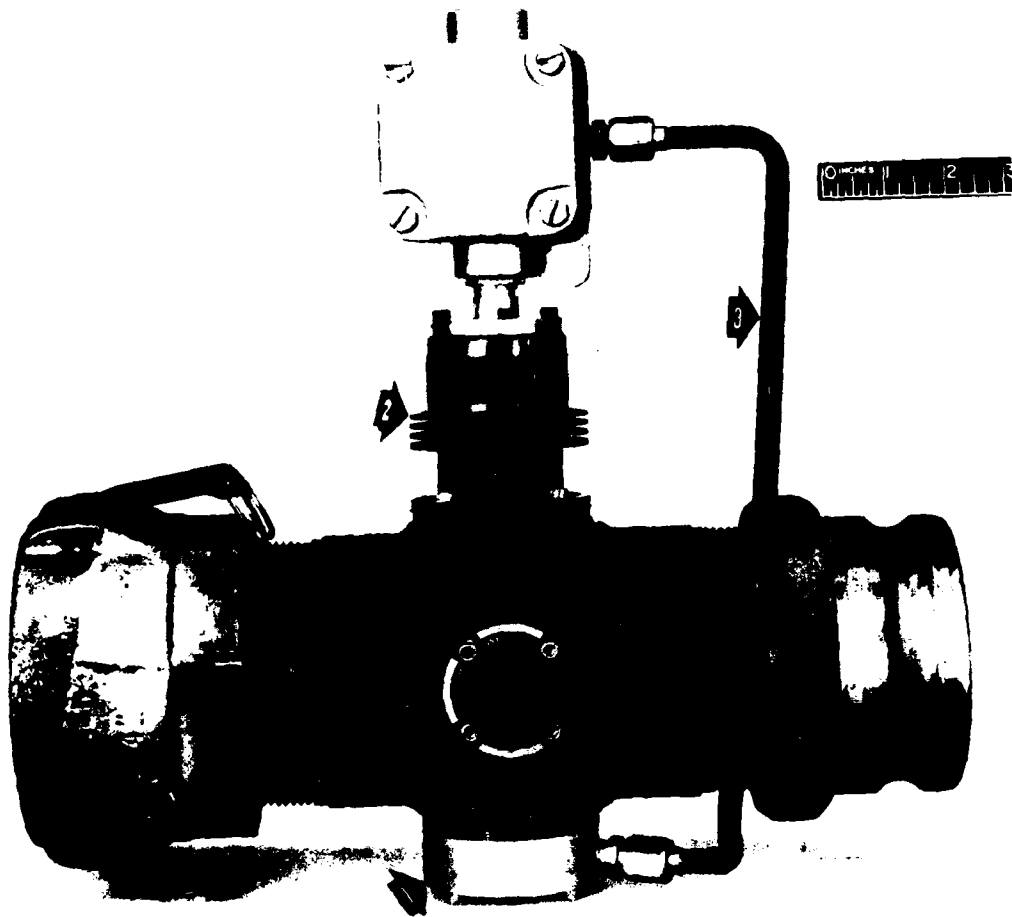
FIGURE 7. EFTT 400 pickup head. 1. Photocell adapter. 2. Lamp adapter  
3. Steel Conduit tube.

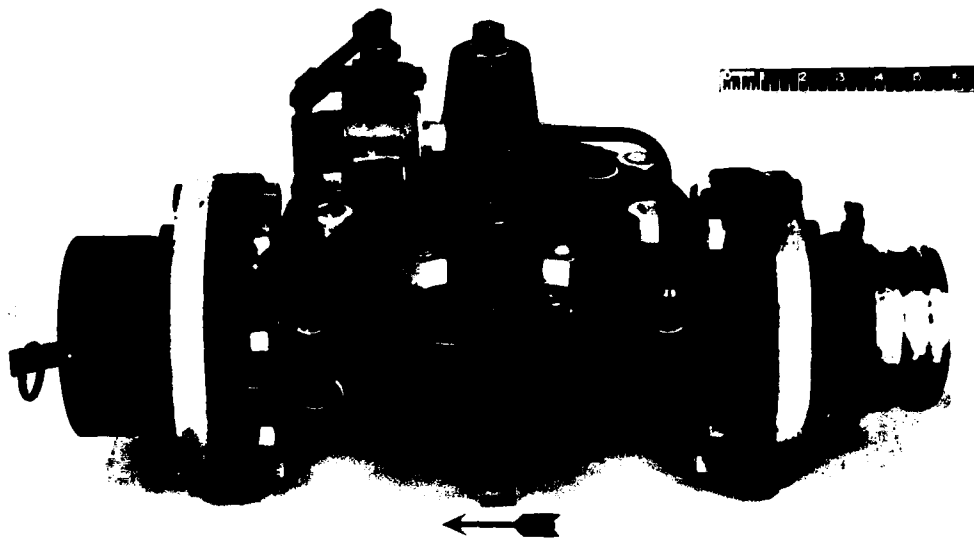
FIGURE 8. EFTT 400 control valve (arrow shows flow direction).

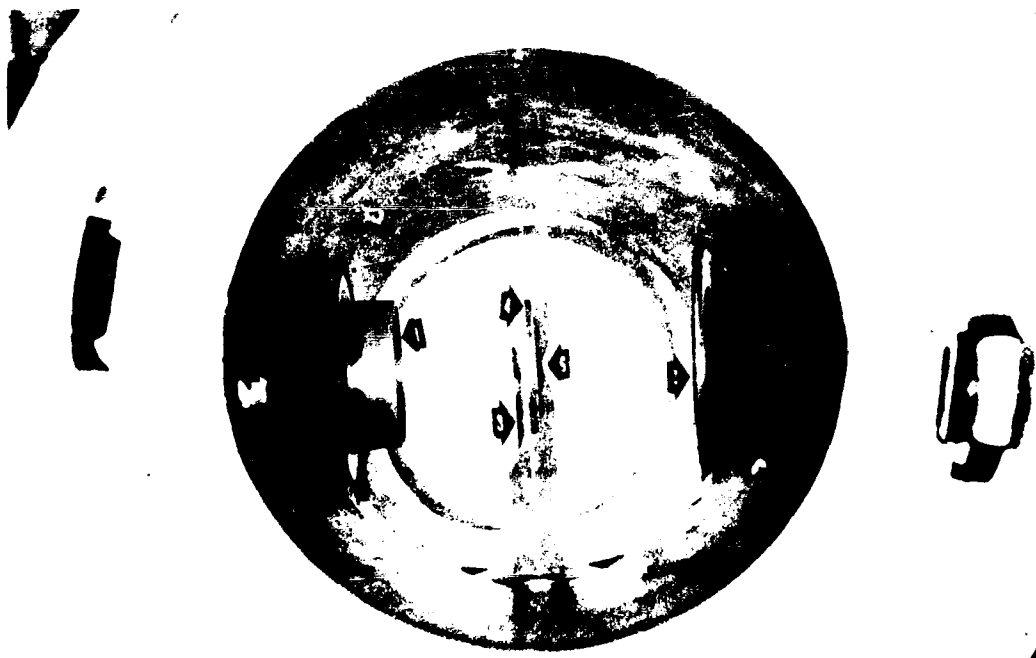
The fuel drip from the pickup head simulator button was not repaired as no replacement O-rings were available. Leakage of high volatility fuel would create a safety hazard. Leakage of DF-1 fuel was not considered too dangerous for test conditions.

FIGURE 9. View inside EFTT 400 picker head (from outlet end). 1. Photocell.  
2. Lamp opening. 3. Simulator slide. 4. Light shield.  
5. Simulation port (open only when simulator button is depressed).

<u>Shortcoming</u>		
Fuel dripped from the contaminate simulator button when button was depressed.	Replace O-ring (packing, preformed, 1/4-in. OD, 1/16 in. thick (08189) 204592).	No replacement parts were furnished with the EFTT's

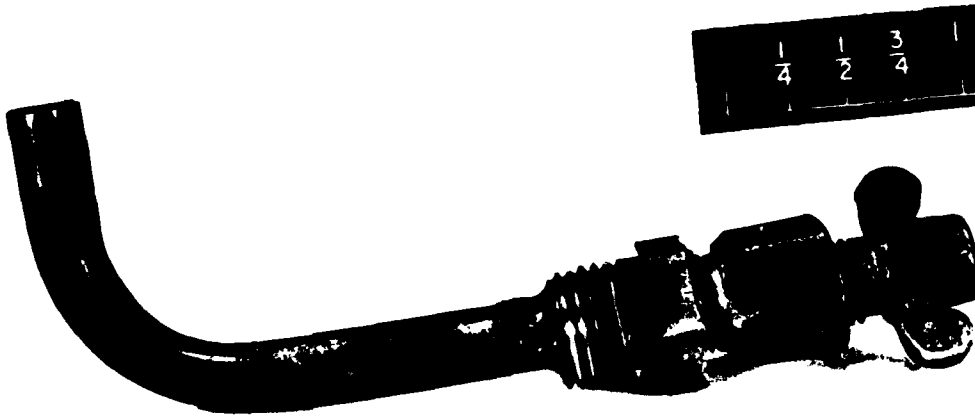
FIGURE 10. Sampling valve (instrumentation).
